## JKT Observatory, Status Report, March 2024.

Here is a summary of the work at the JKT.

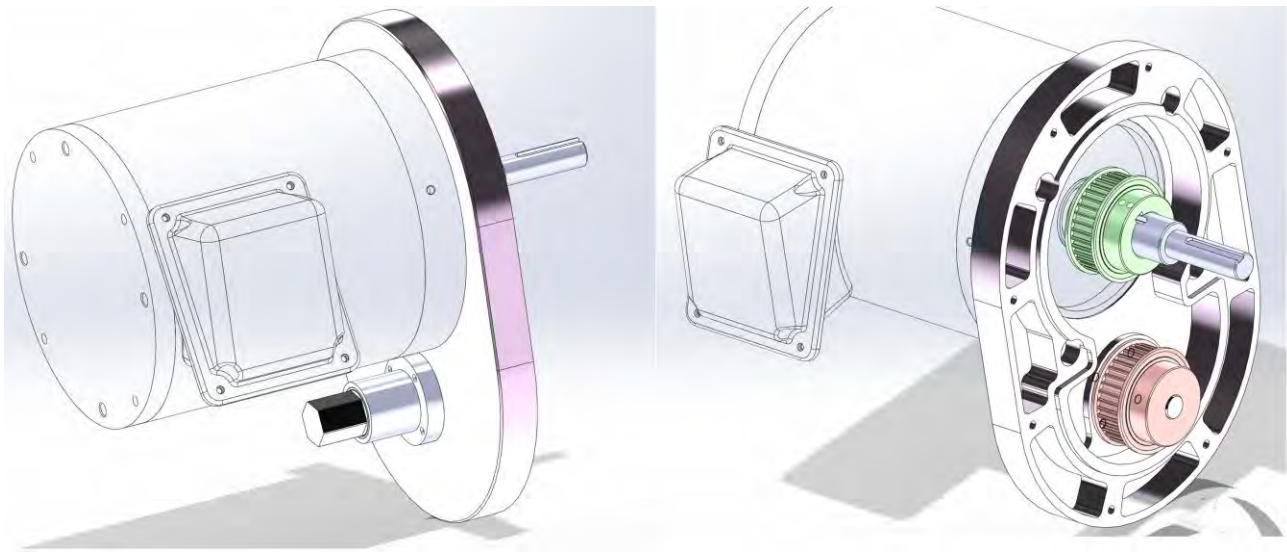
I then realized, after my visit in November, that there was an important feature missing in the design of the new gearbox/motor for the dome. In the old setup the back of the motor has a 22mm hexagonal shaft sticking out of the back. A long wrench, similar to a car tire change tool, fits on the shaft and allows the dome to be opened and closed manually. This feature is not available on the replacement motors.

I therefore designed an inline gearbox to solve this problem. That was definitely not trivial, as I had my hands tied with pre-existing dimensions.

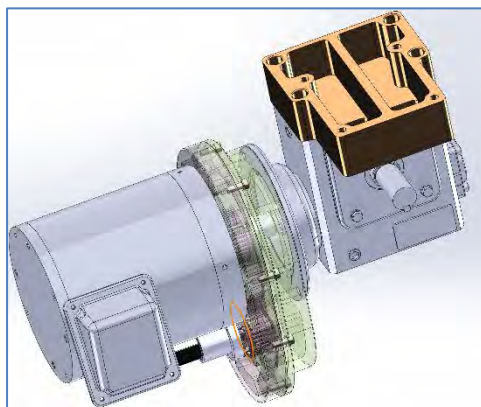
The (almost) finished assembly. You can see the spacer at the top, which sets the correct height. Not shown we had to fabricate a new drum, drum shaft, bearing spacers, and so on.

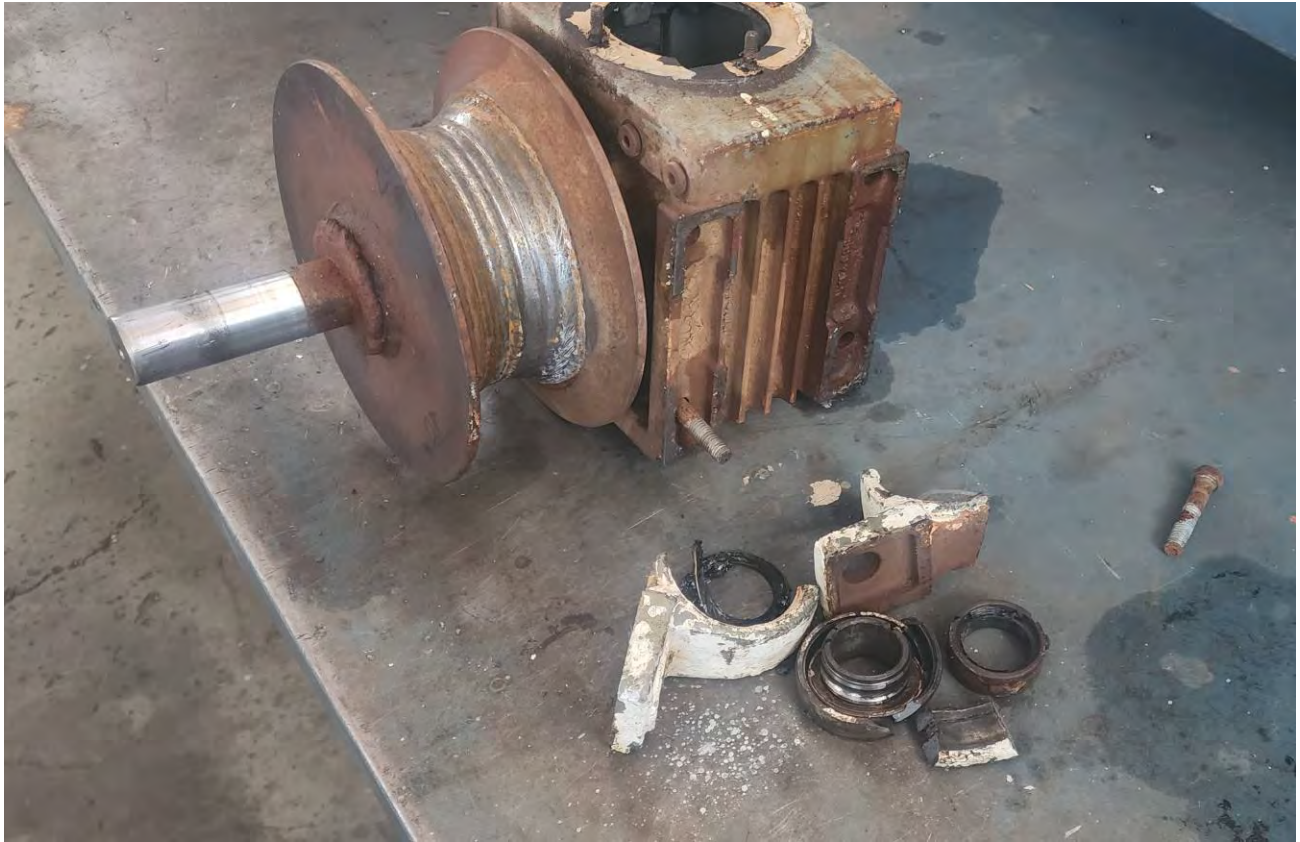
My belief that the drum could not be taken off the old gearbox turned out to be true. When the IAC staff tried to disassemble things the bearing block broke apart and the drum (a.k.a. “the Capstan”) was an integral part of the gearbox.

I am in two minds whether or not to have that sent back to Tucson so we can salvage the drum. The replacement drum seems to be working fine, but it is made of aluminum.

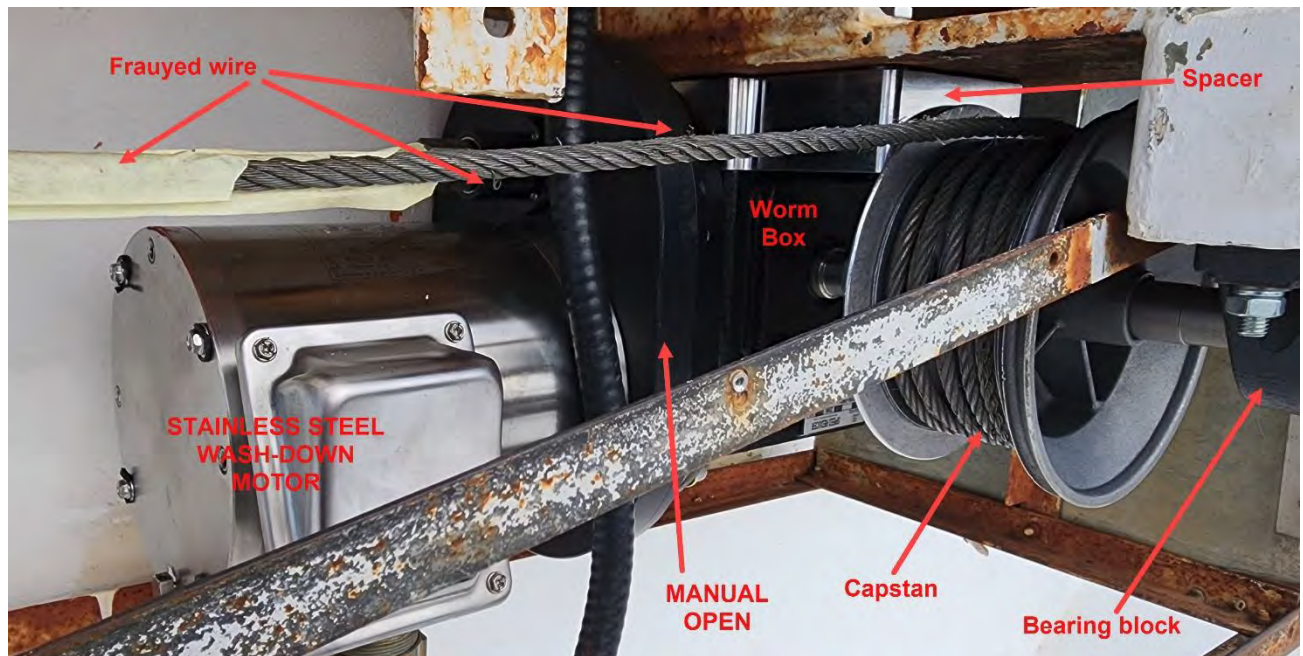
Here is the new assembly. The new motor is a stainless-steel washdown inverter duty type of motor.

It's hard to tell it this photo, but some of the clearances are very tight, less than a few millimeters, and installation was a real pain. A couple of days with an angle grinder, drilling tapping, etc. Trying to get simple parts on the fly is really difficult on the island. I think I know every industrial supplier on La Palma!

You will note the painters' tape over the wire. The wire rope is frayed with ultra-sharp little pieces sticking out. I got it stuck on my arm and boy, that was not nice! The tape was my attempt to protect my arms during assembly and on the whole it worked. Here is a close-up view of the wire rope, with the fraying.

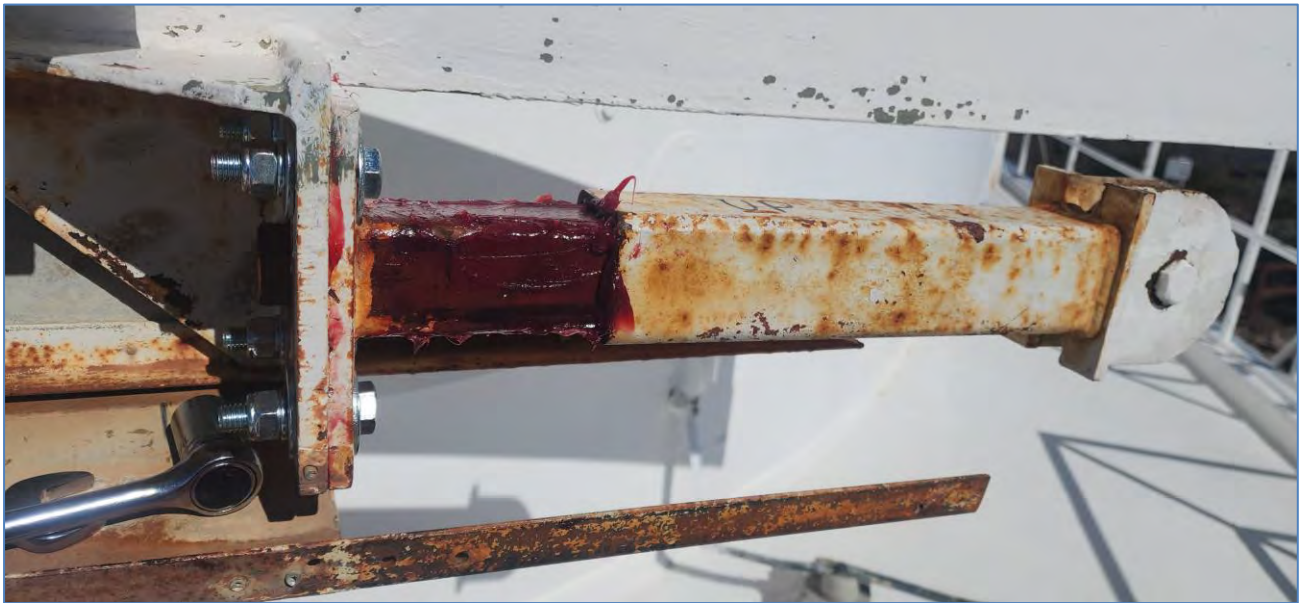
The wire has to be at the correct tension, and the tensioning bar was not working.

I took that apart and serviced it. The main leadscrew had seized up and there was zero grease in the assembly. I replaced all the fasteners.

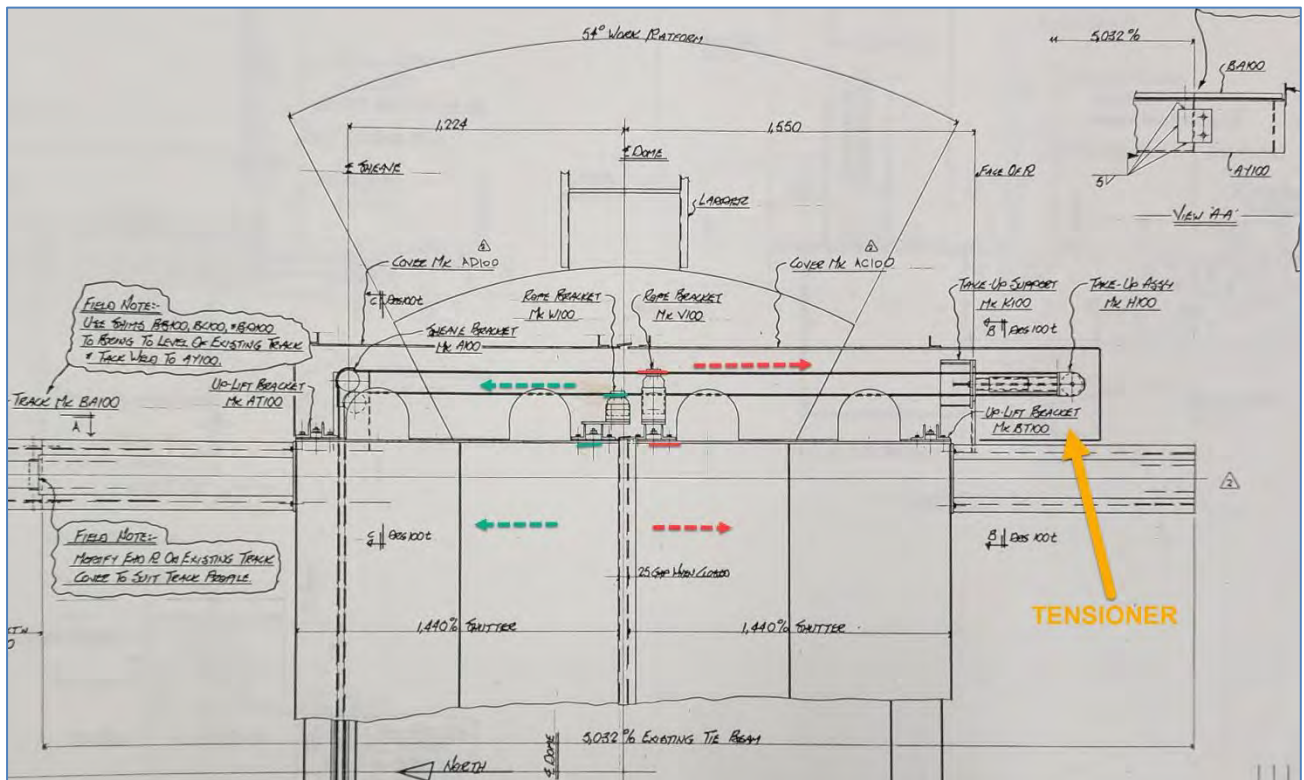
Here is a diagram showing the top of the dome. I will try to explain how it works and have annotated parts to help in this endeavor. The **GREEN** parts are for the left-hand door, and the **RED** parts are for the right-hand door.

We know that the wire rope is not broken. What we believe is wrong is that one or both of the clamping mechanisms that attach the door to the rope have become loose. This means that the door(s) are not effectively attached to the rope and the result is that the doors bind. If we take the doors and shake them, we can, with considerable effort, get them to open while moving the hand crank.

These mechanisms are repeated on the lower section of the rope, and I had to service them. They are attached by 5/16-18 bolts into tapped holes. The threads on the lower bolts had stripped out and we believe the same has happened with the top pair of clamps. They should be replaced with Grade 8 fasteners. Unavailable on the island.

A two-man bucket lift is required to gain access to the service areas. One is readily available for rent on the island, and we will need it for a week, because there is more than one thing it will be used for.

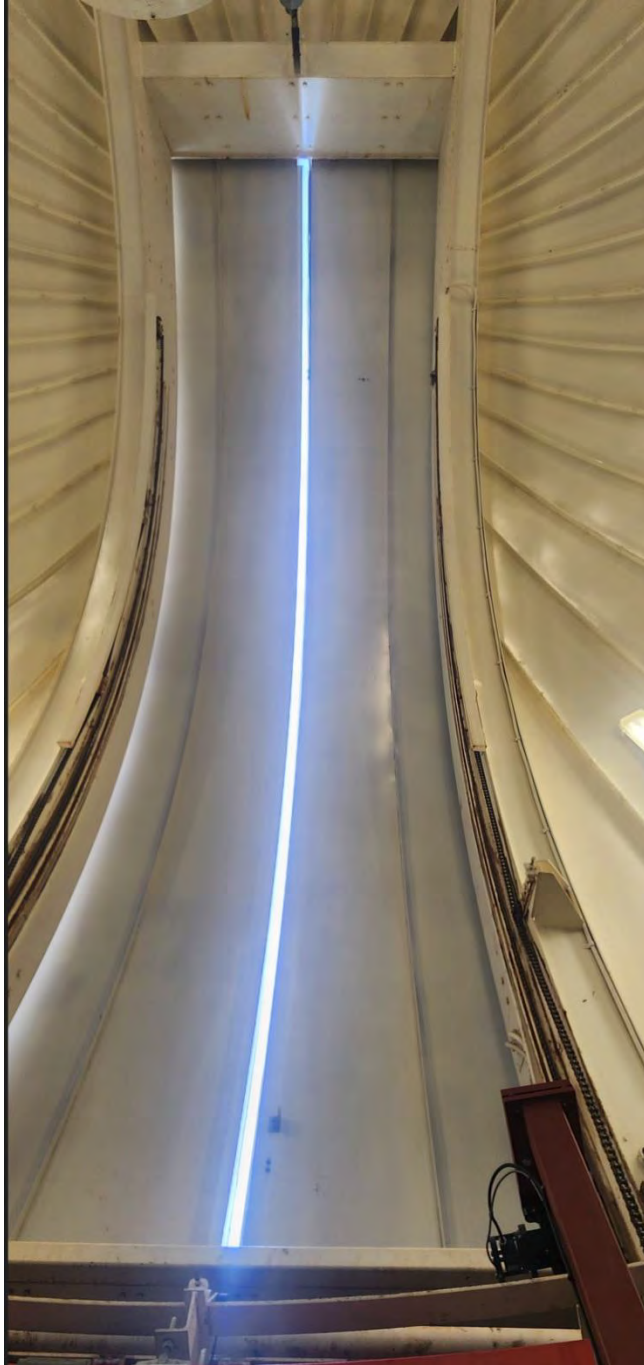
This image shows that the doors are not closing parallel, which supports the theory that the clamping mechanisms at the top are loose.

The weather seal must be replaced. Even when the doors really are fully shut (touching each other) rain can get in.

To replace the weather seal, we have to open the shutter doors and then remove some long-curved sections that are sandwiching the rubber on.

They are held on by  $\frac{1}{4}$ -20 x 1.5-inch socket head cap screws. Difficult to get off; we need to take an impact driver tool.

The weather seal is available at several suppliers and I am getting samples to check for the stiffness of the rubber.
