## JKT Observatory, Status Report, March 2024.

Here is a summary of the work at the JKT.

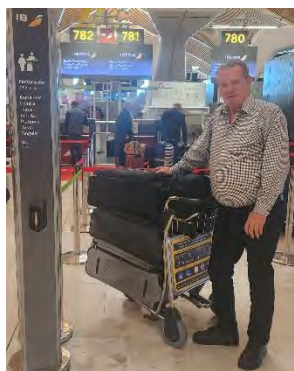
The parts, together with adapter plates and spacers we fabricated in our shop, were shipped in three consolidated boxes 09 November by UPS international 3 day.
